# TIGER TIPS

## Mold-cured Rubber Jackets VS Continuous Vulcanized (CV) Jackets for Mining Applications

Third-party Test Results

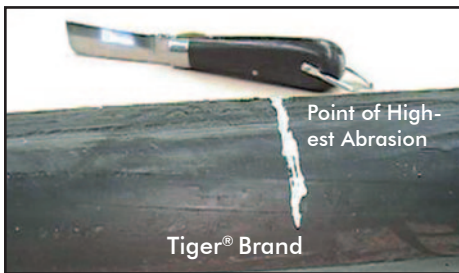
### ■ Tiger® Brand

Virtually no abrasion on jacket after 15,000 Cycles

*The Tiger® Brand mold-cured jacket showed virtually no abrasion at the conclusion of the 15,000 cycle test*

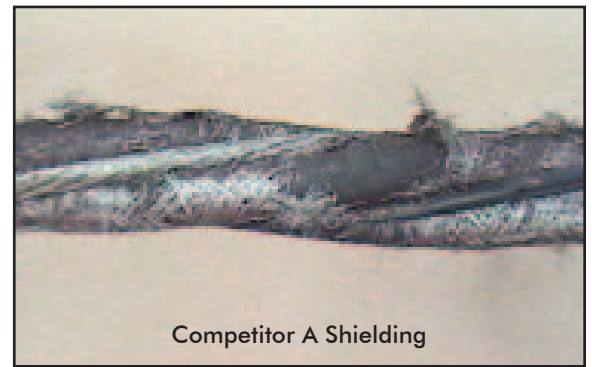
- Competitor A – Herringbone strand opened up and destroyed the shielding, caused wear on insulation and subsequent DC Hipot failures on two-phase conductors and GC. This failure occurred at 2,500 cycles. (see photo)
- Competitor B – Test terminated after 4,715 cycles due to ground check failure. Electrical test (IR) on EP insulated power conductors was low even at this point.
